Field Evaluation of an Autoisokinetic Stack Particulate Sampling System

Entropy Environmentalists, Inc, Research Triangle Park, N C

EPA-600/2-77-035

February 1977

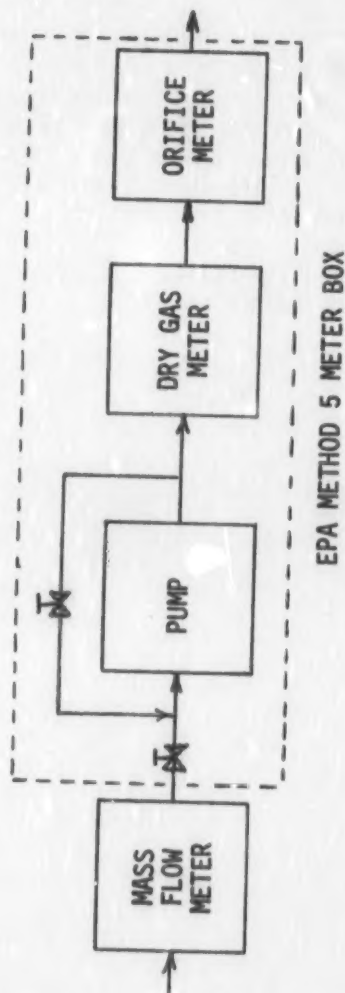
Figure 3. Sampling train flow diagram, calibration

A leakless self-oiling pump of the type used in a typical EPA Method 5 particulate sampling train meter box was substituted for the carbon-vane pump and the dry gas meter was placed in-line after the leak-free pump. The mass flowmeter was retained in the system, remaining between the umbilical and the vacuum pump as shown in Figure 3.

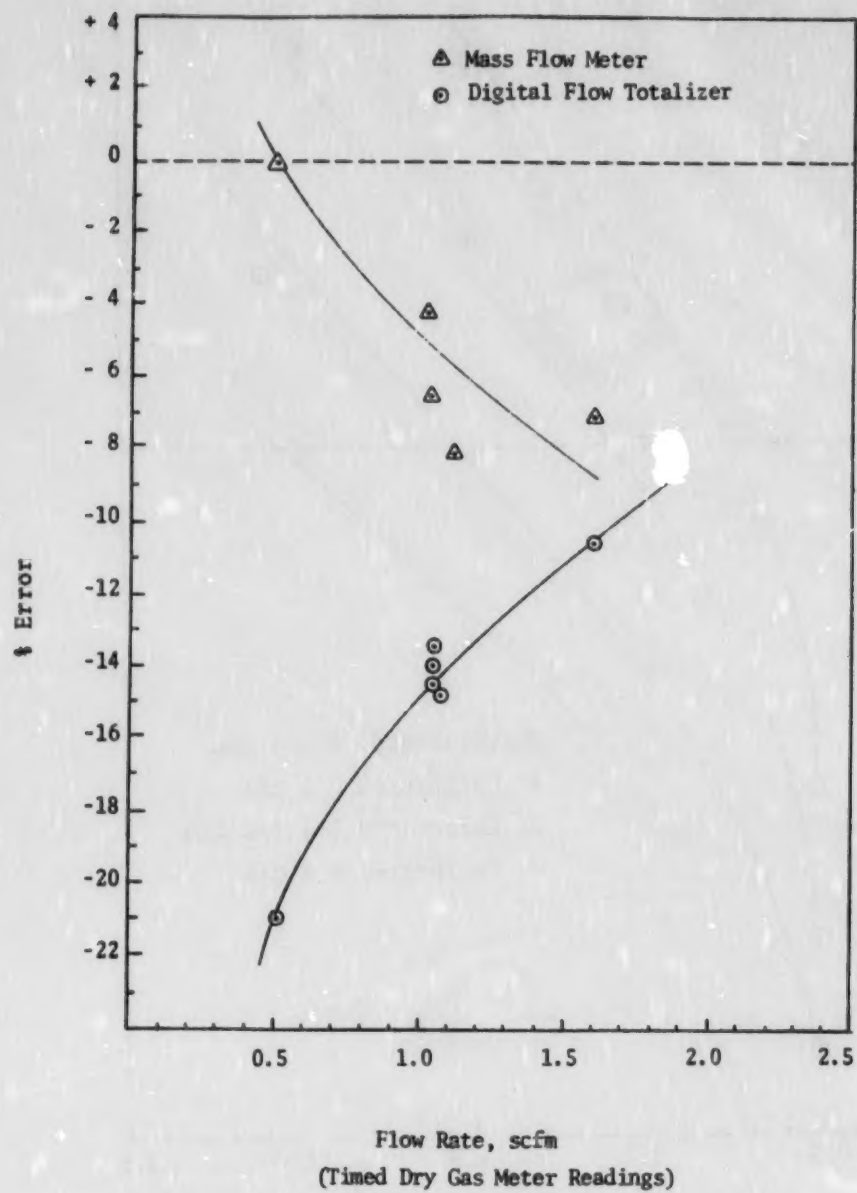
Calibration checks were made on the digital flow totalizer and mass flowmeter with the results as shown in Figure 4. The mass flowmeter was corrected somewhat by adjustment of the calibration potentiometers labeled "meter" and "gain" but the flowmeter was still out of calibration. The totalizer could be calibrated for a given constant flow, but when the flow was decreased, the totalizer read lower than the actual value, and when the flow was increased over the calibrated flow setting, the totalizer read higher than the actual value. The totalizer would not respond to flows less than 0.2 - 0.3 cfm. Calibrations for flow rates are presented in Figure 5. The mass flowmeter was taken to a Hastings-Raydist office for a manufacturer's calibration. The flowmeter was designed to operate at flows up to 5 cfm. Specifications for the flowmeter are $\pm 1\%$ of full scale. At a flow rate of 0.5 cfm, therefore, an error of 10% is allowed by the specifications. The Hastings-Raydist engineers calibrated both the flowmeter and the totalizer. The final calibration adjustment still yielded a positive 5% bias for both meters. The results are given in Figure 6. Figure 7 gives a typical mass flowmeter calibration curve.

Figure 4. Calibrations of flow meter and totalizer as originally furnished

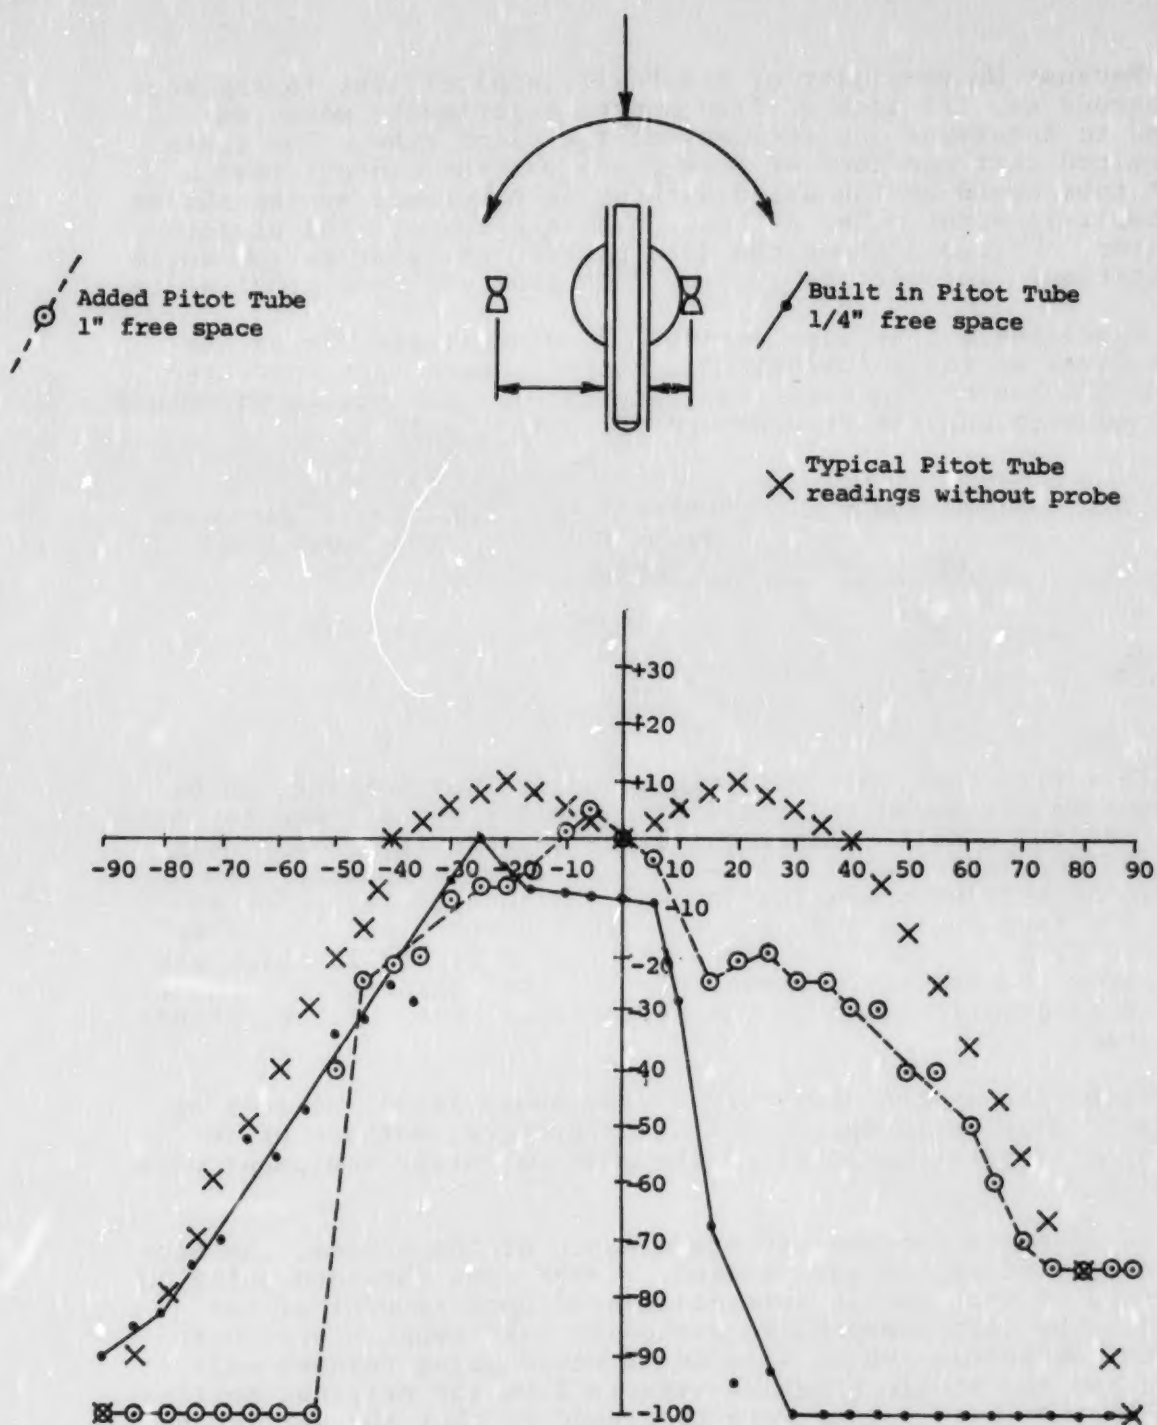
Because the proximity of the built-in pitot tube to the nozzle shroud was 1/4 inch of free space, experiments were conducted to determine the accuracy of the pitot tube. The tests determined that one inch of free space was the closest that a pitot tube could be installed without interference by the shroud. The built-in pitot tube, at best, had an error of -10% at zero rotation. Figure 8 shows the data plotted as error versus angle of rotation. Included is typical data from a S-type pitot alone.

Figure 8. Pitot tube error

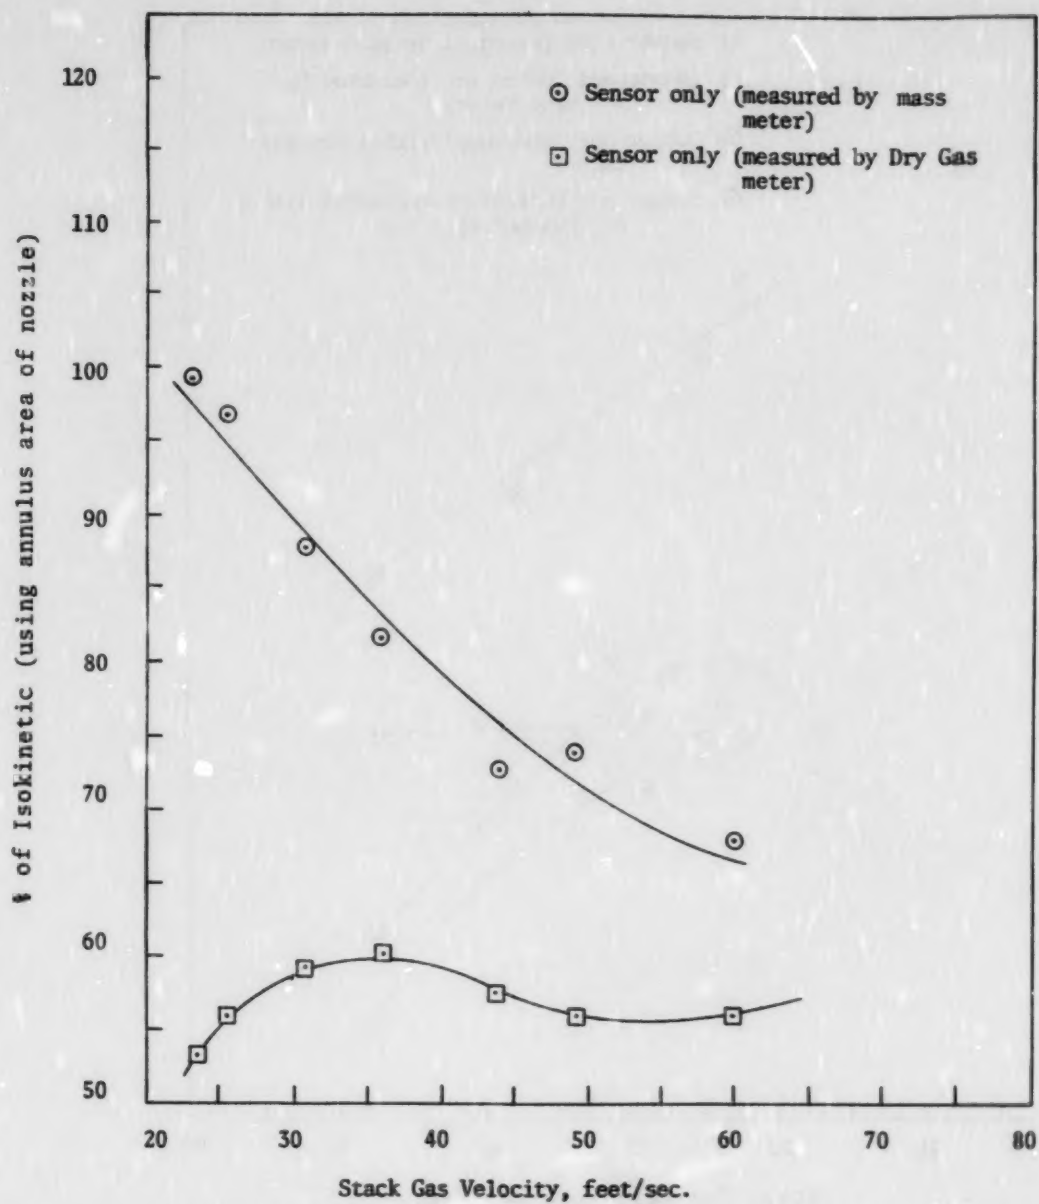
Figure 9. Performance of the 1/4 inch nozzle, as received

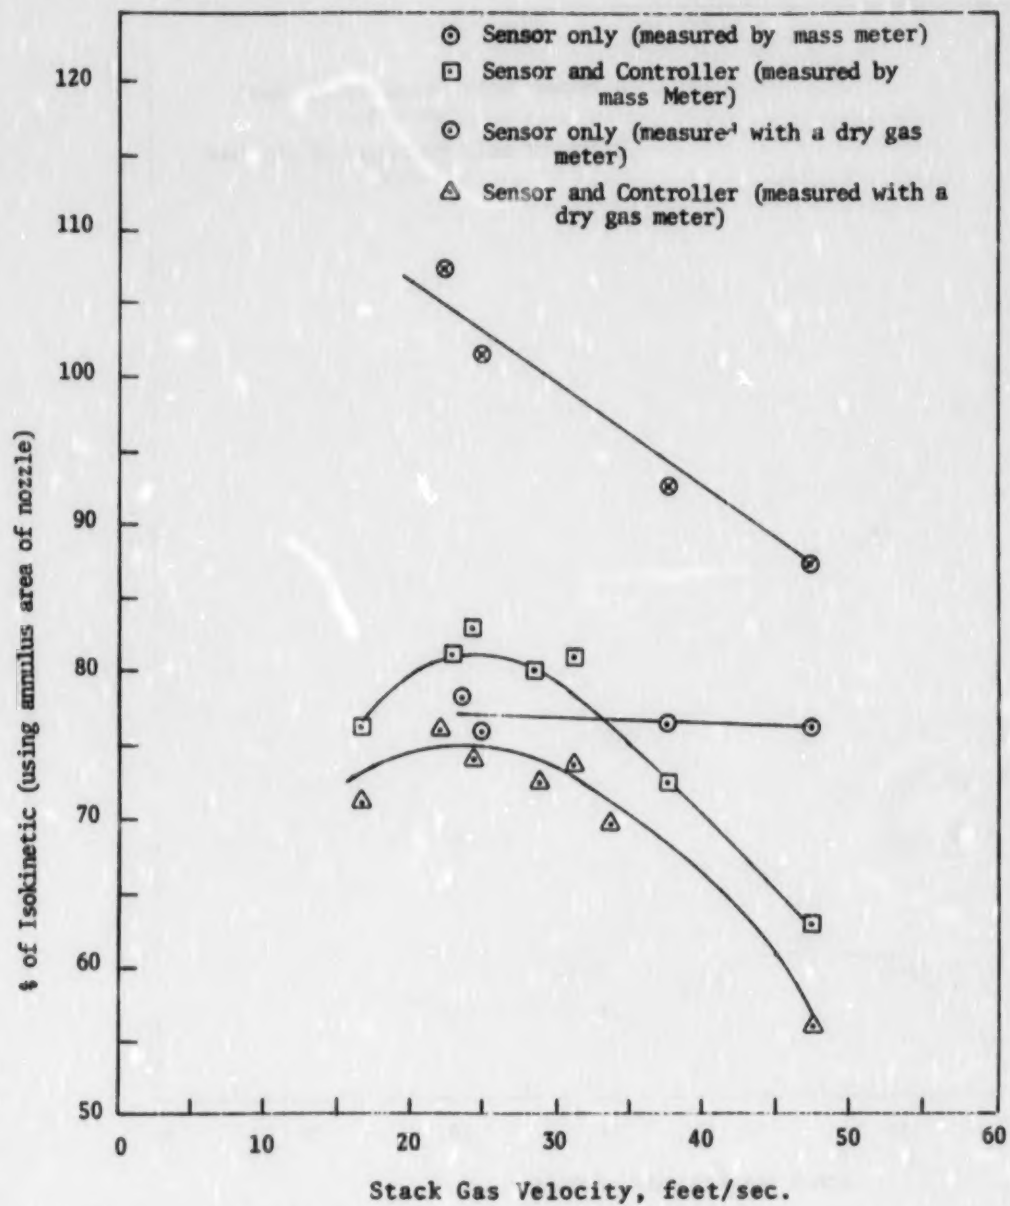
Figure 10. Performance of the 3/8 inch nozzle as received

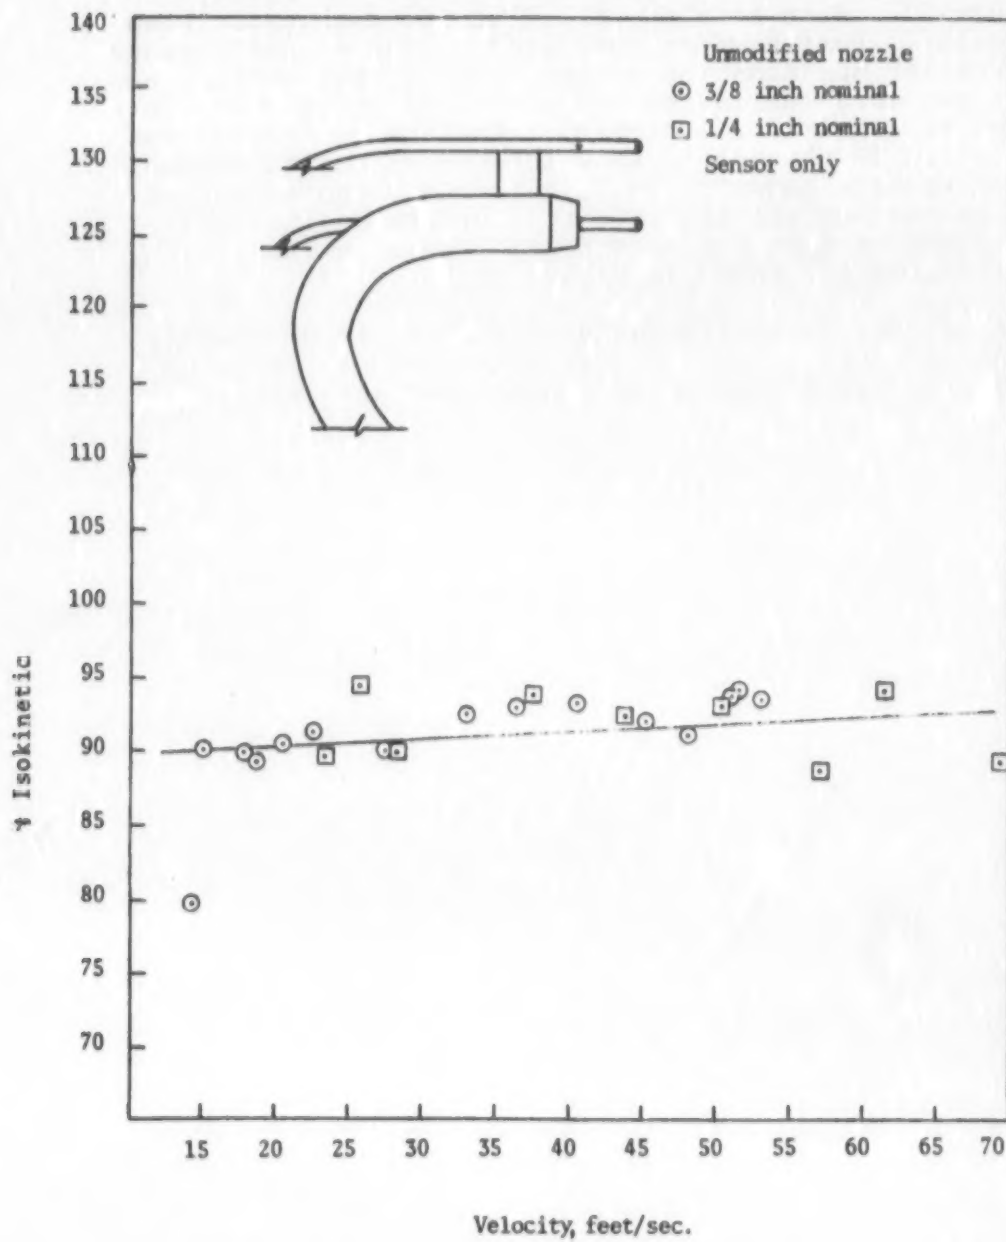
With the new nozzles, the null balance system operation was rechecked, again by-passing the controller, with the results as shown in Figure 13. Both nozzles nulled at 90% isokinetic when operated manually. Past history indicated a drop in performance when the controller operated the system. Therefore, further nozzle modifications were fabricated and tested to achieve an operating level of at least 110% isokinetic when the controller was bypassed. Figures 14 through 19 show the sensor modifications tested and the results thereof. Modification #7, consisting of the pressure holes, was finally selected for the new nozzles. The results of the "sensor and controller" tests on the final modified nozzles are presented in Figure 20.

Figure 13. Performance of unmodified nozzles

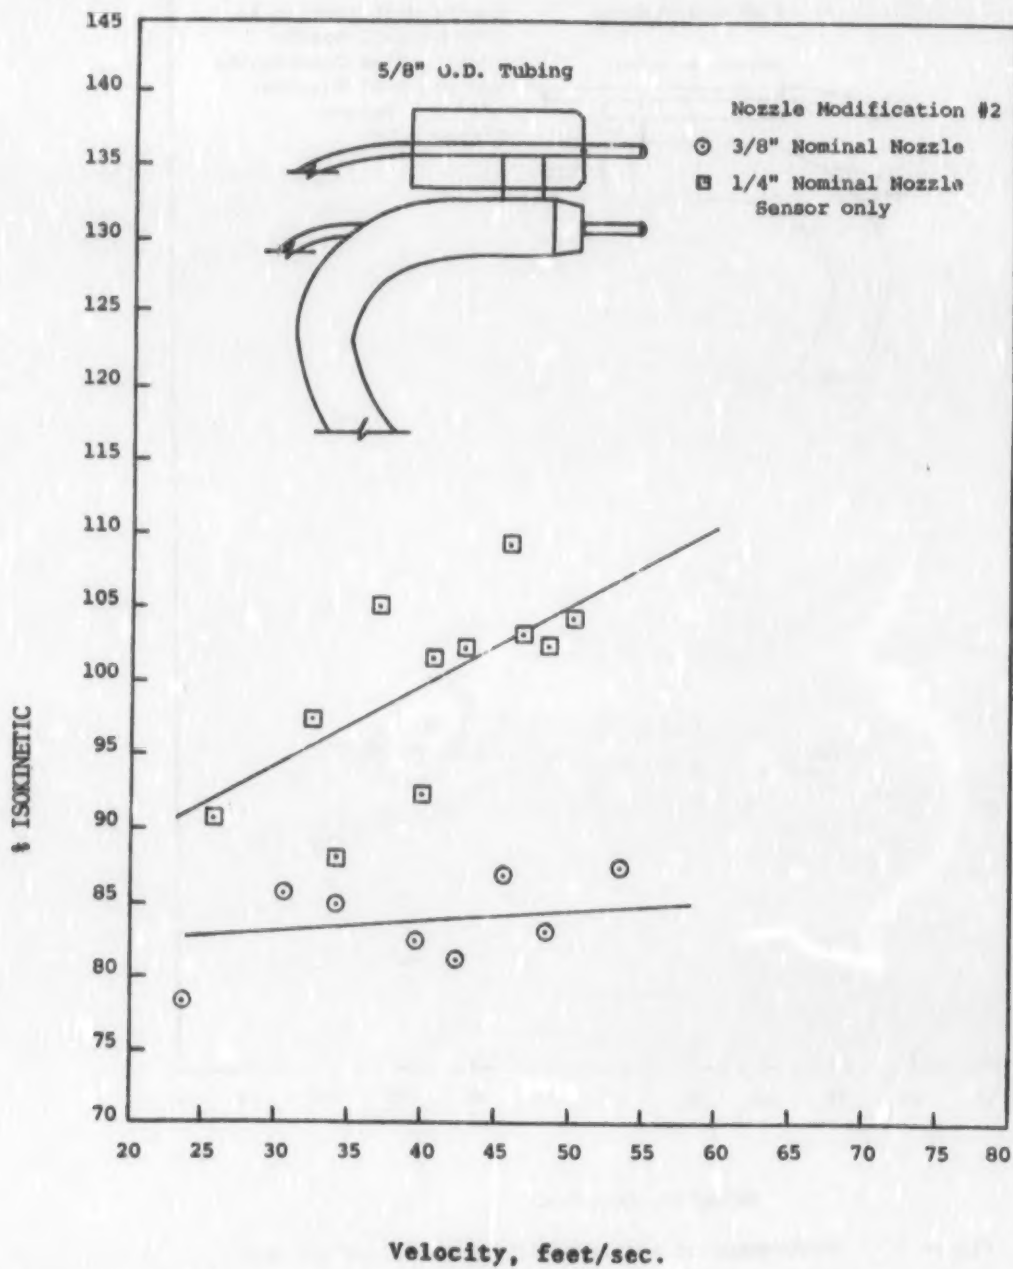
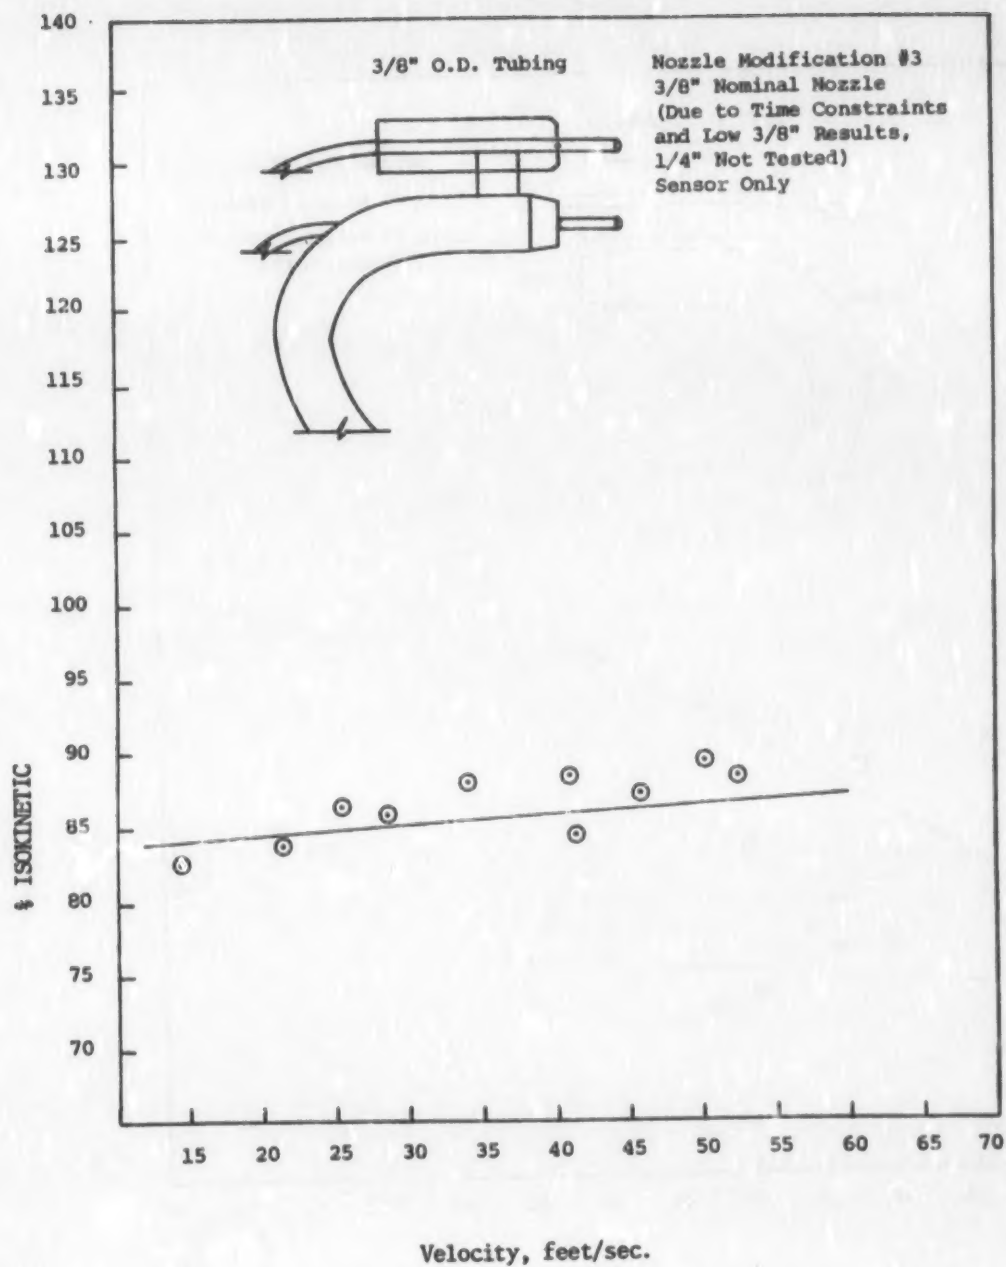
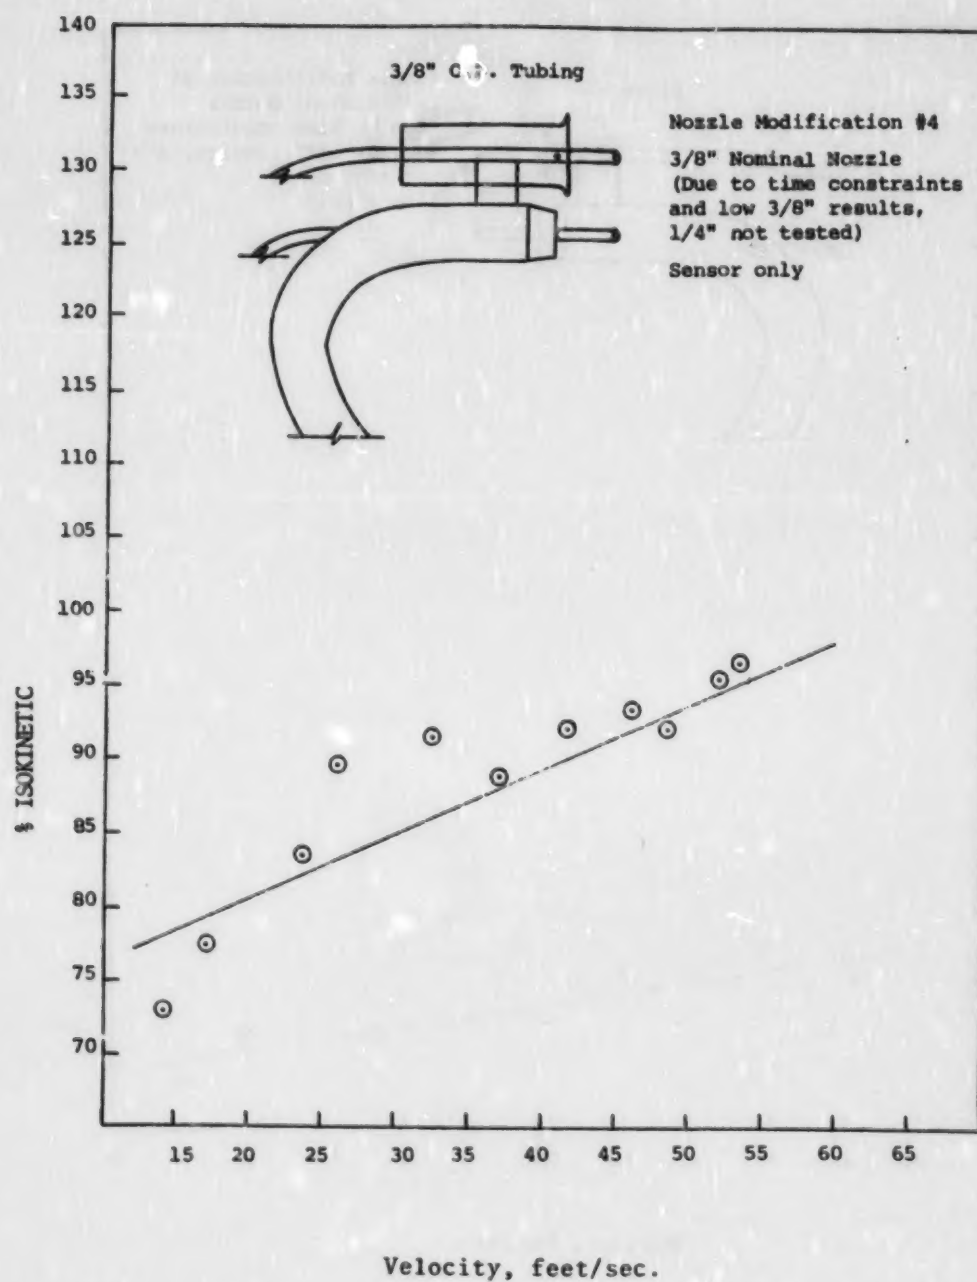
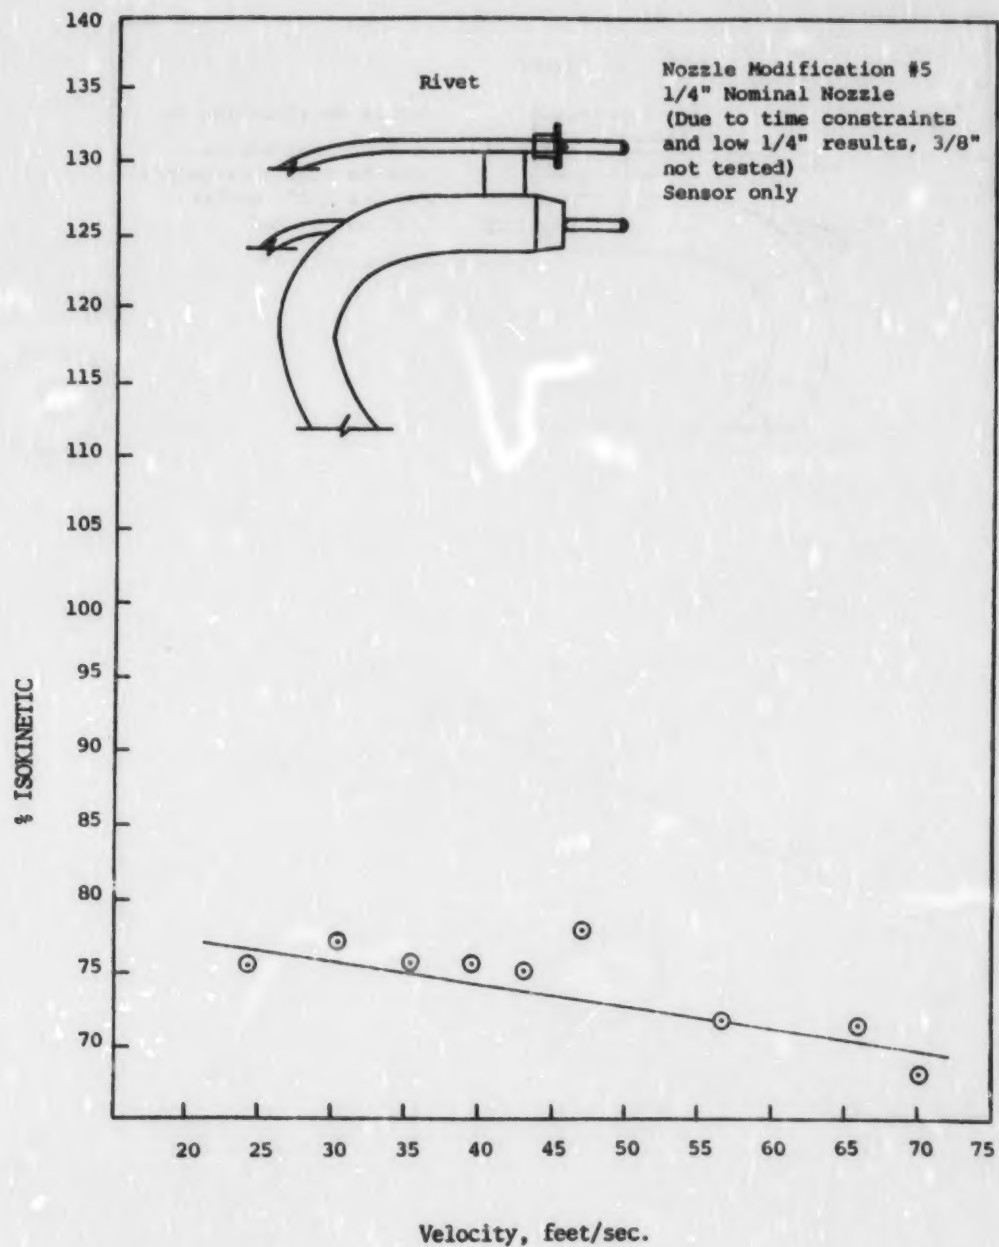
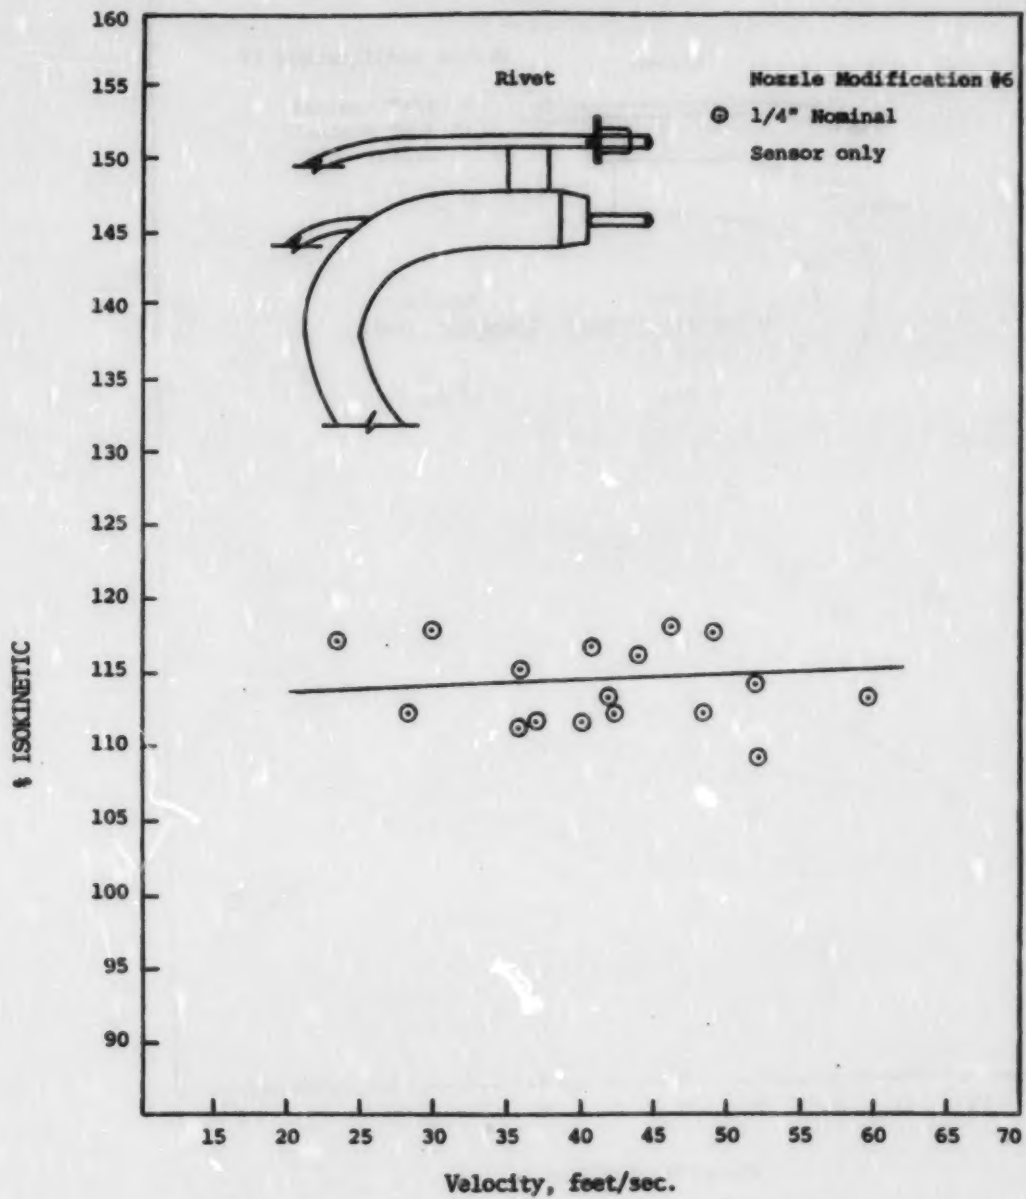
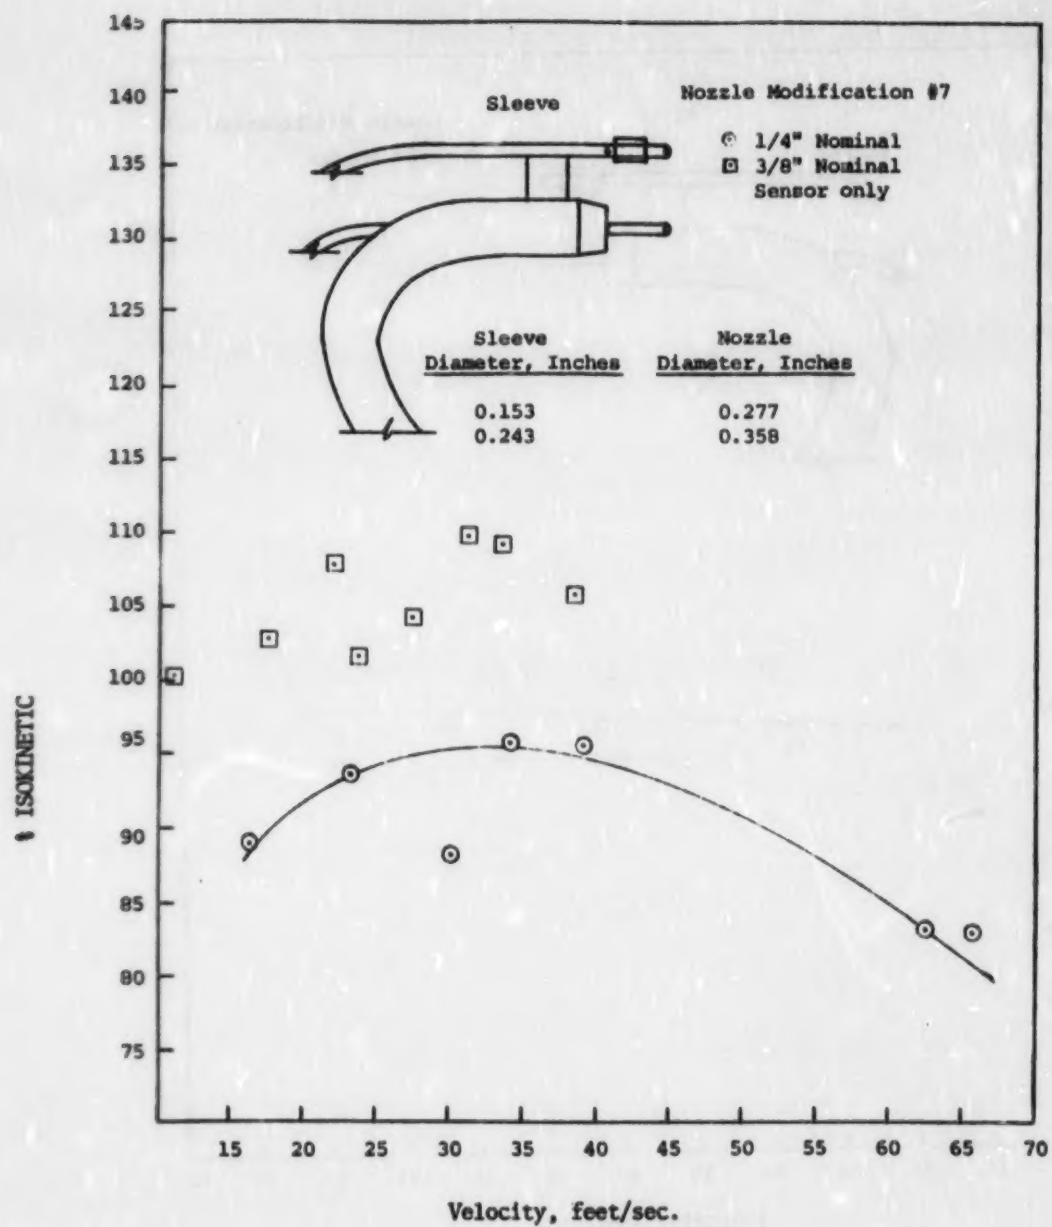
Figure 14. Performance of nozzle modification #2, sensor only

Figure 15. Performance of nozzle modification #3, sensor only

Figure 16. Performance of nozzle modification #4, sensor only

Figure 17. Performance of nozzle modification #5, sensor only

Figure 18. Performance of nozzle modification #6, sensor only

Figure 19. Performance of nozzle modification #7, sensor only

In order to improve the performance of the system, the nozzle protective shroud was removed. Large open threaded holes in the sides of each nozzle were discovered upon removal of the shroud. The most inexpensive method to make repairs was to fabricate new nozzles which were constructed using thinner wall tubing and the static pressure sensors from the original nozzles. Also, the new nozzle tips were shortened so that the nozzle and pitot tube were on the same plane. The protective shrouds were left off.

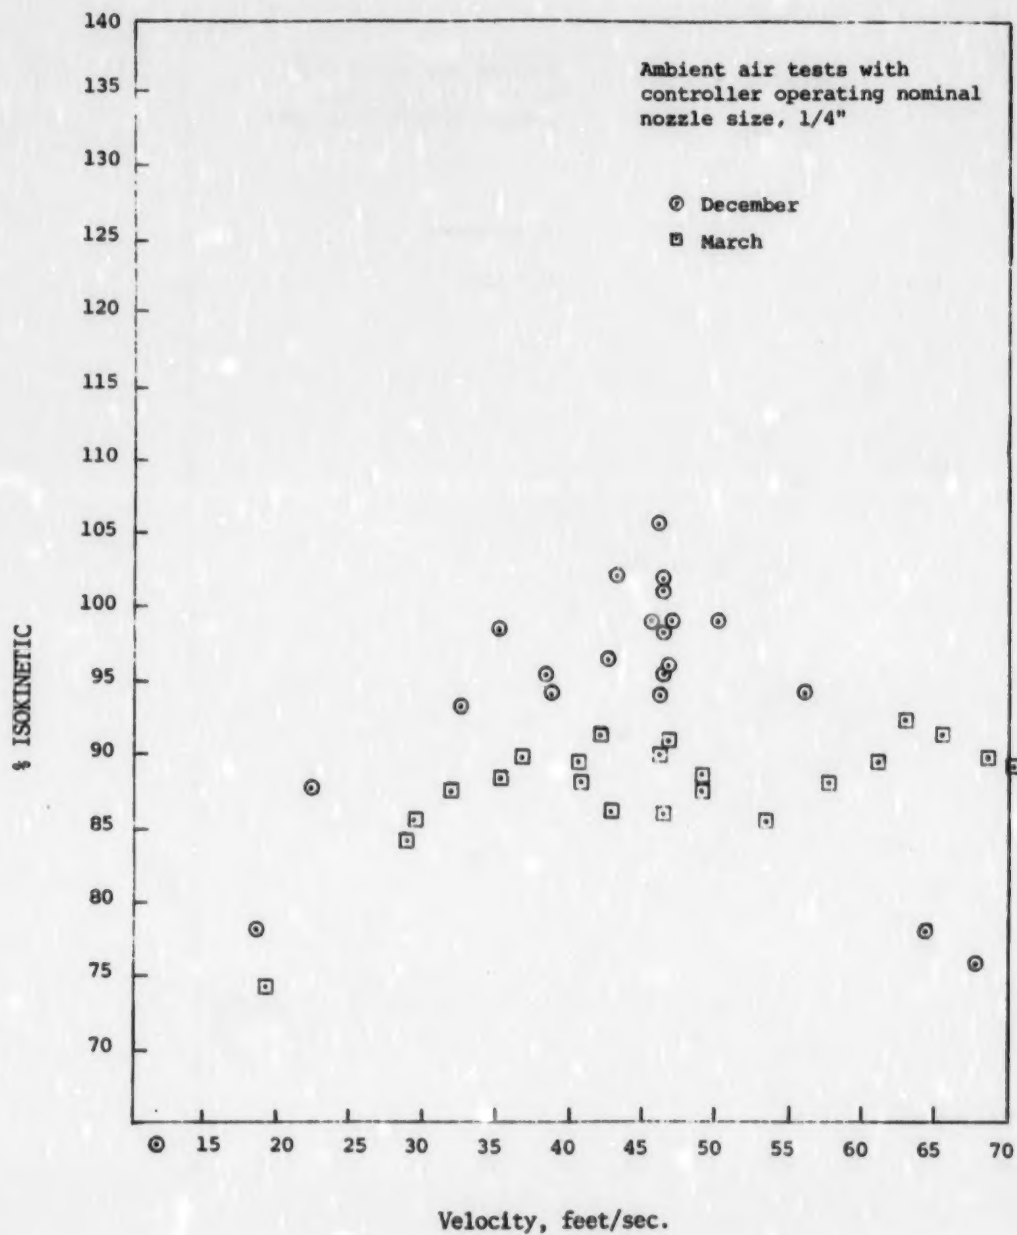
With the completion of the last field test, the equipment was again setup at the SSSF in order to compare the post-test operation with the pre-test operation. The results are shown in Figures 21 and 22. A slight drop in performance seems to have occurred during field tests.

Figure 21. Performance of final 1/4 inch nozzle, pre-field and post-field testing

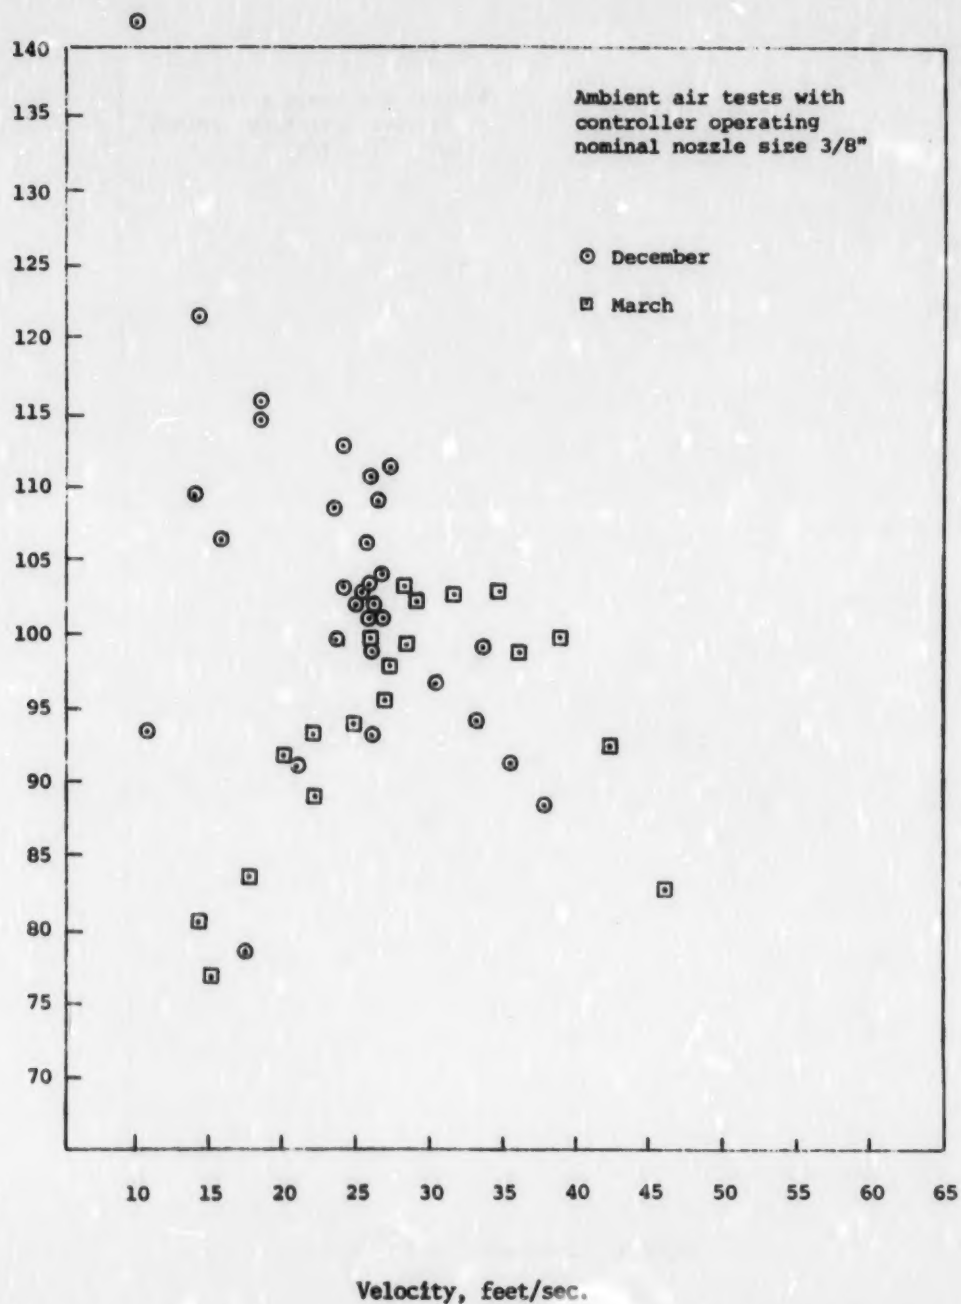
Figure 22. Performance of final 3/8 inch nozzle, pre-field and post-field testing

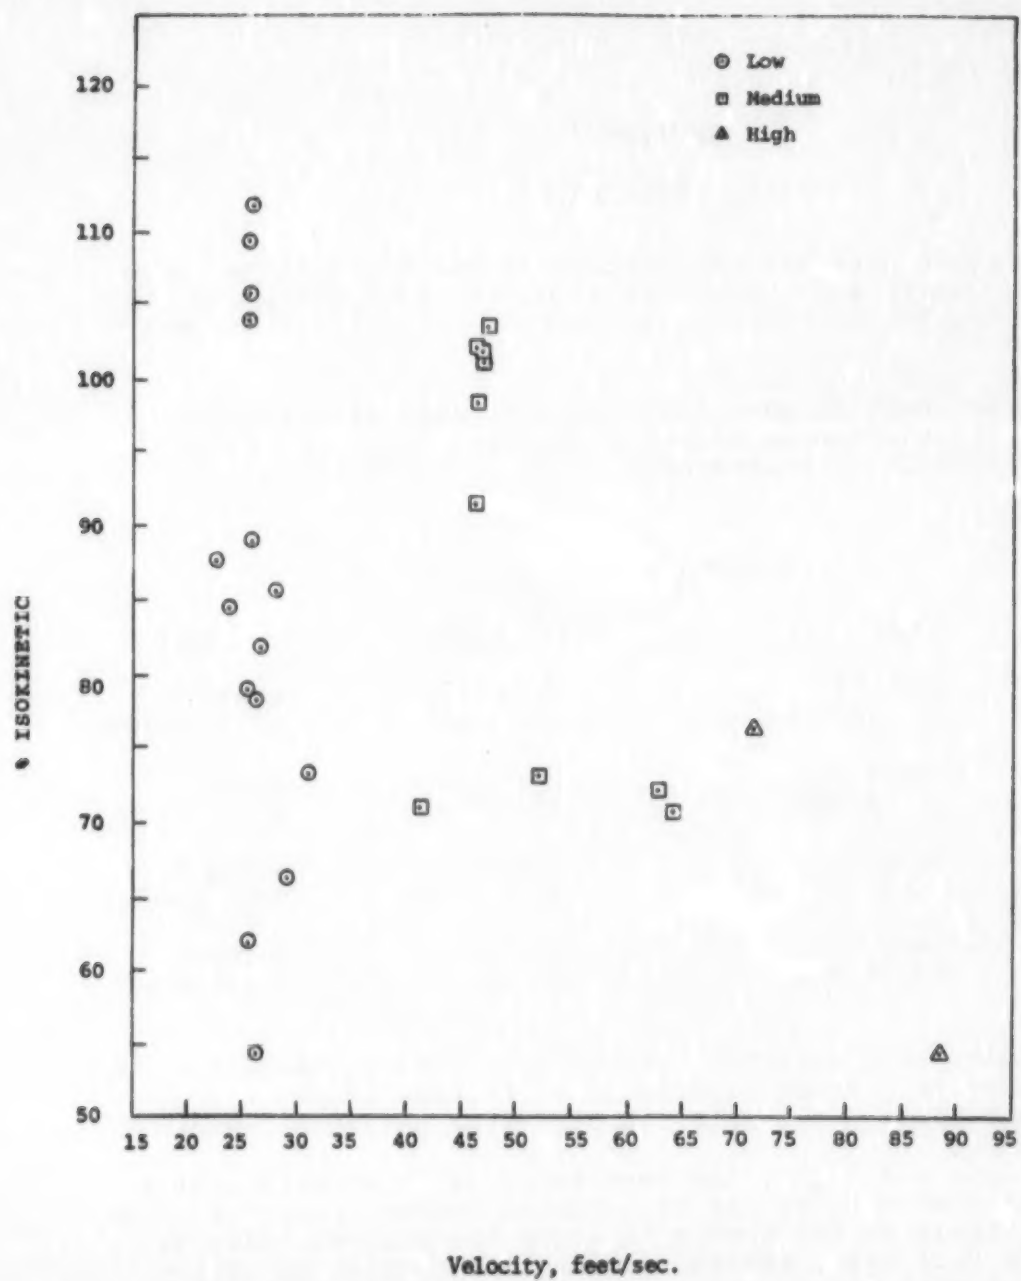
The results from each test in the specified parameter ranges are plotted versus percent isokinetic in Figures 23, 24, and 25. Note that some sources fit into two different parameter ranges.

Figure 23. Gas stream velocity versus percent isokinetic

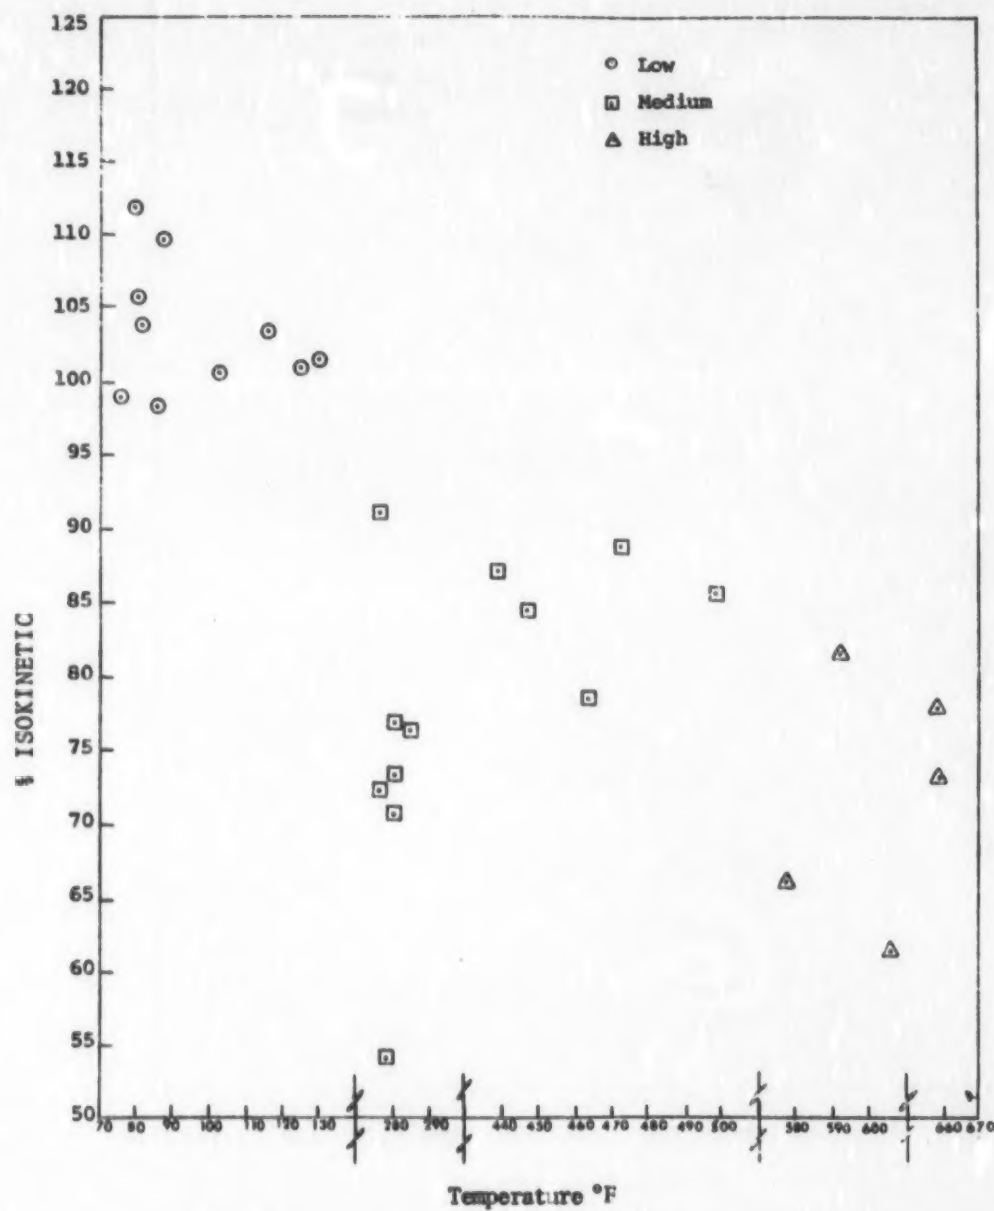
The results indicate that the percent isokinetic is inversely related to the temperature of the gas stream sampled. Relationships between the operating percent isokinetic for the autoisokinetic sampler and gas stream velocity, temperature and particulate loading were sought. The particulate loading and gas stream velocity had no noticeable effect on the percent isokinetic. However, a correlation was observed between the gas stream temperature and the percent isokinetic. For the sources tested, the temperature ranged from 74°F to 659°F and the percent isokinetic ranged correspondingly from 112% to 61%.

Figure 24. Gas stream temperature versus percent isokinetic

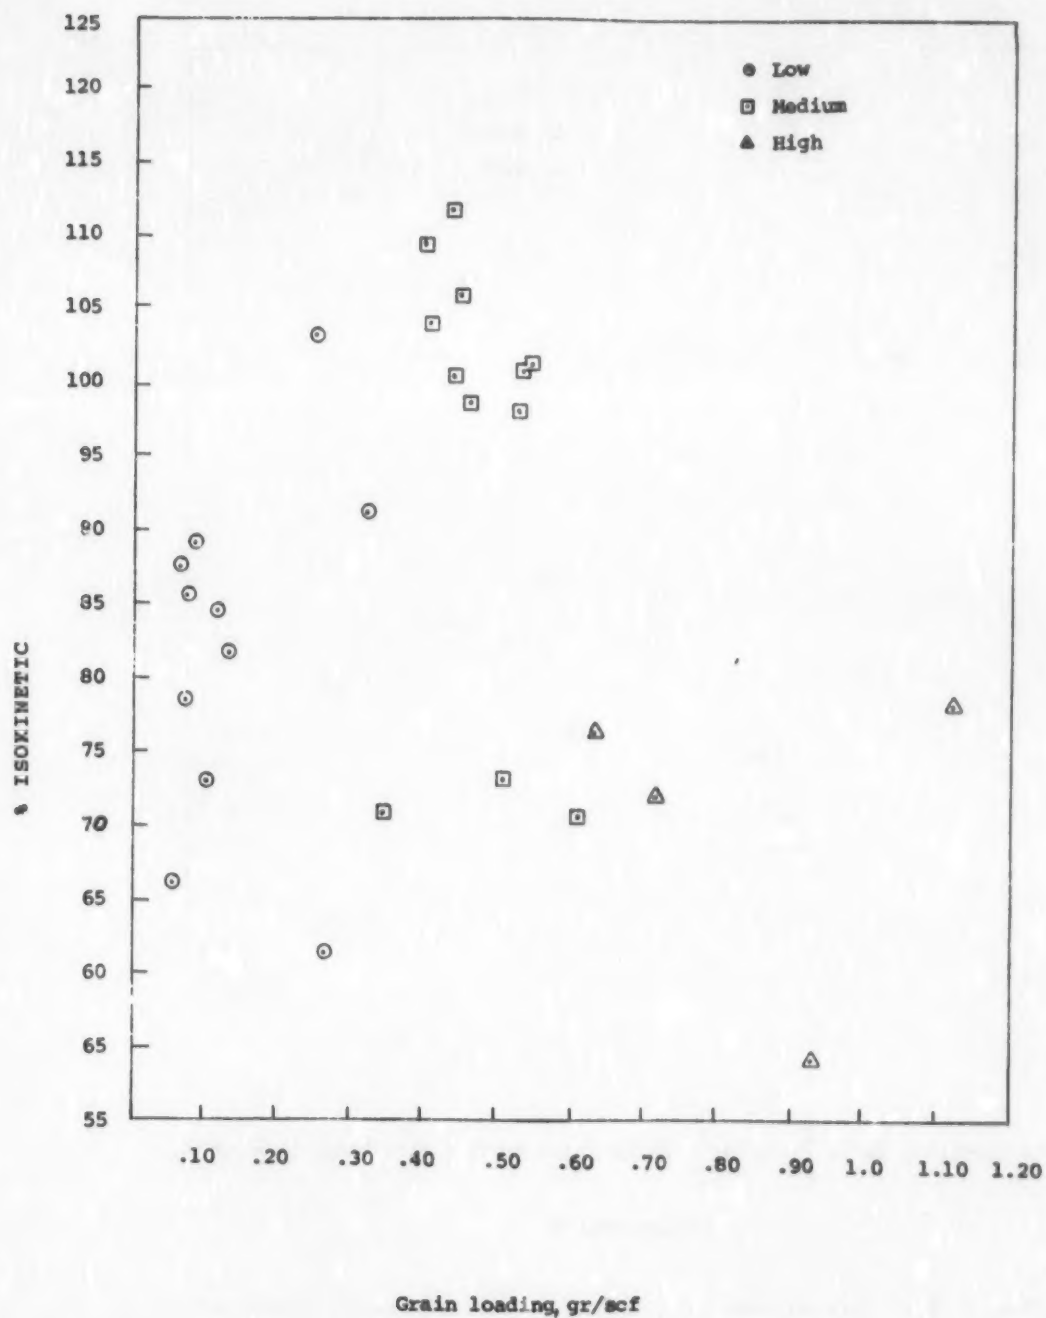
Figure 25. Grain loading versus percent isokinetic
